APOLLO 11 ASTRONAUTS DID NOT TAKE THE APOLLO 11 MOON PHOTOS AND VIDEOS

A SCIENTIFIC PROOF OF AN APOLLO 11 HOAX

By
FRANCISCO VILLATE

Version 3 – January 6, 2024

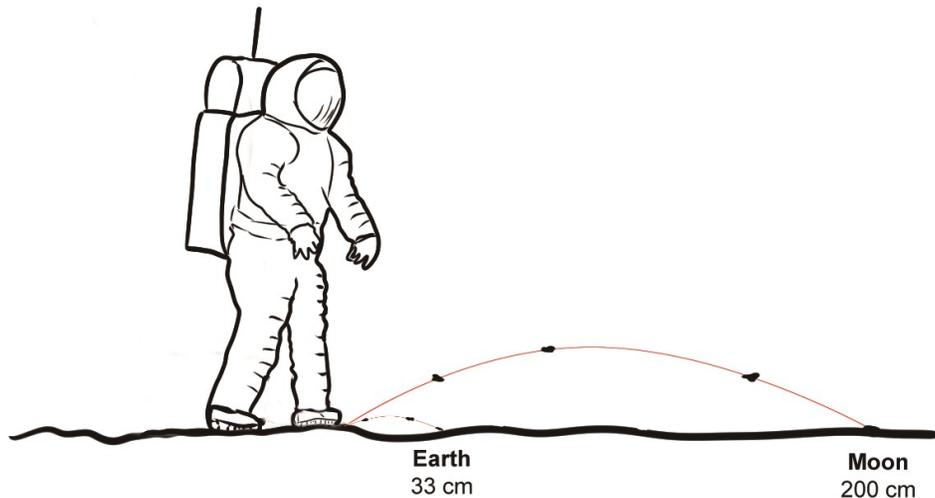
Figure 3 – Comparison of particles movement.

How do the respective soil particles react, and why is the response different on Earth from the Moon? After being kicked, every soil particle of dust, sand, grains, or gravel involved has an initial velocity. The particles fly away at different angles. In an environment with an atmosphere, like the Earth, the air or atmosphere creates a drag effect that reduces the speed of small or light particles, and they fall close to the source or foot. The bigger and heavier the particles, the less air drag they receive. So, the big particles fall faster, the tiny light grains slower, and the dust keeps falling for a long time.

In a vacuum environment, somewhat like the Moon, this does not happen. All particles, independent of their weight, size, or shape, fall at the same speed. Gravity creates an additional effect. The higher the gravity, the faster the particles fall. So, particles fall fast on Earth but slower on the Moon. A particle flying from a bootkick follows the laws of physics. With no air in a vacuum and on the Moon, they will not face a drag effect to slow them down and will fly more freely following a parabolic orbit. With the Moon's low gravity, the particles fall slower, touching ground farther away after their parabolic flight, as shown in the NASA videos.

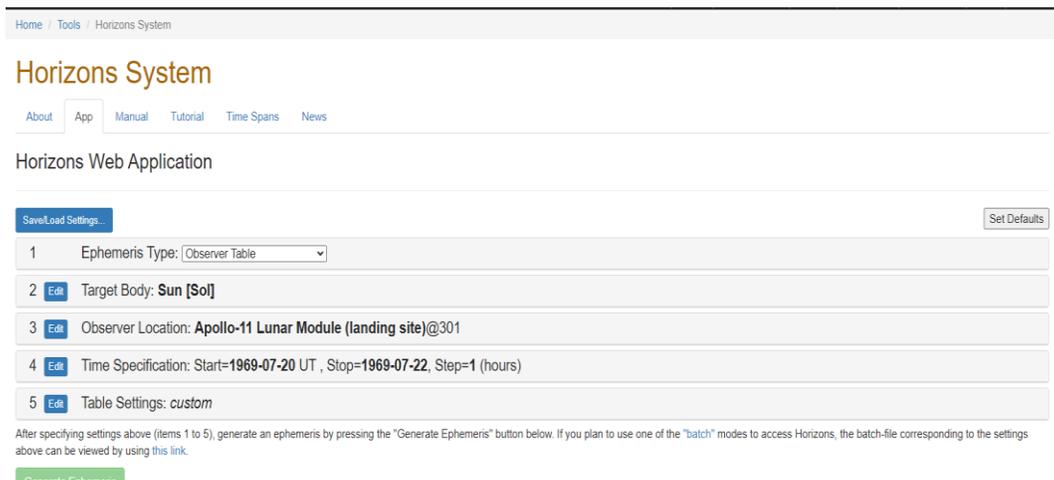
Figure 4 - Using the Horizons tool

Moreover, at the JPL site, NASA offers a tool called Horizons to calculate the Sun’s elevation at each instant and precisely where the Apollo 11 lunar module supposedly landed in the Sea of Tranquility (Horizons System). Figure 4 above shows a view of the Horizons tool for observing the Sun. The location of the Apollo 11 landing site was selected using Horizons, which can give a range of start and end times (in universal time) and intervals of 1 hour, 10 minutes, or whatever is required. In Settings, we choose to show the elevation and azimuth of the Sun to define what we want to record and report. With Horizons and the hourly data of each event, we can know the exact elevation of the Sun above the lunar horizon. The results in Table 1 show the timing and Sun’s elevation angle for each photo we chose to analyse.

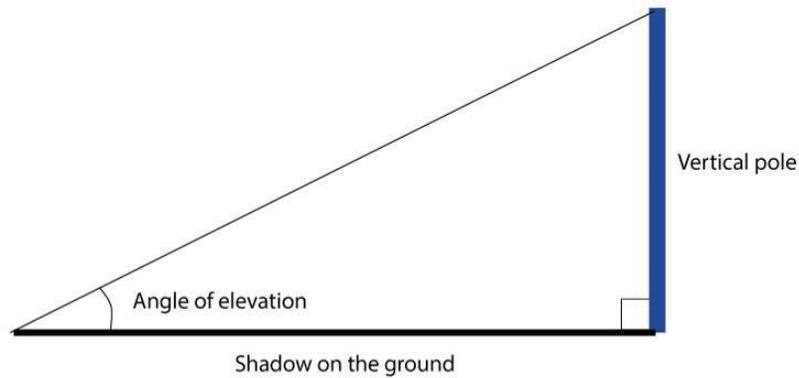
Figure 5 - Triangle to measure Sun elevation angle.

Imagine looking at a vertical pole and the shadow it casts. The pole and the shadow line are two legs of a right triangle. Calculating the angle is easy after accurately measuring the vertical leg, that is, the pole or elevation of the instrument, and the horizontal leg, represented by the length of the shadow. As we know from basic trigonometry, the ratio of these two measurements is the tangent of the angle; therefore, we can calculate the angle with the inverse function. In Method 1, the triangle measured must be in front view for best accuracy, with the shadows cast from right to left or left to right, not in perspective towards the horizon. Not all Apollo 11 archive photos show this feature, and sometimes, the end of the shadow is not visible in the picture.

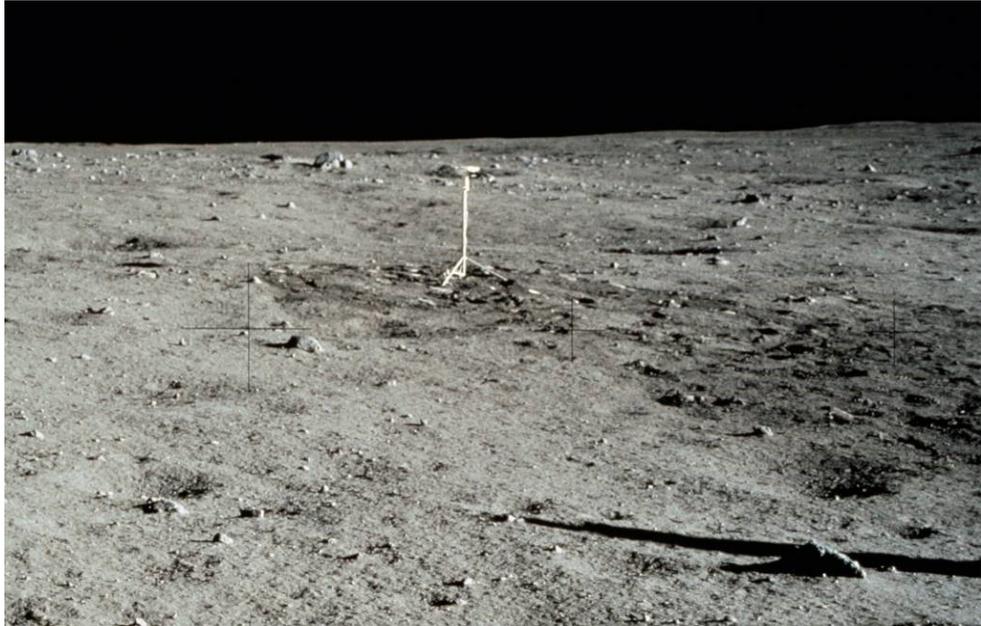
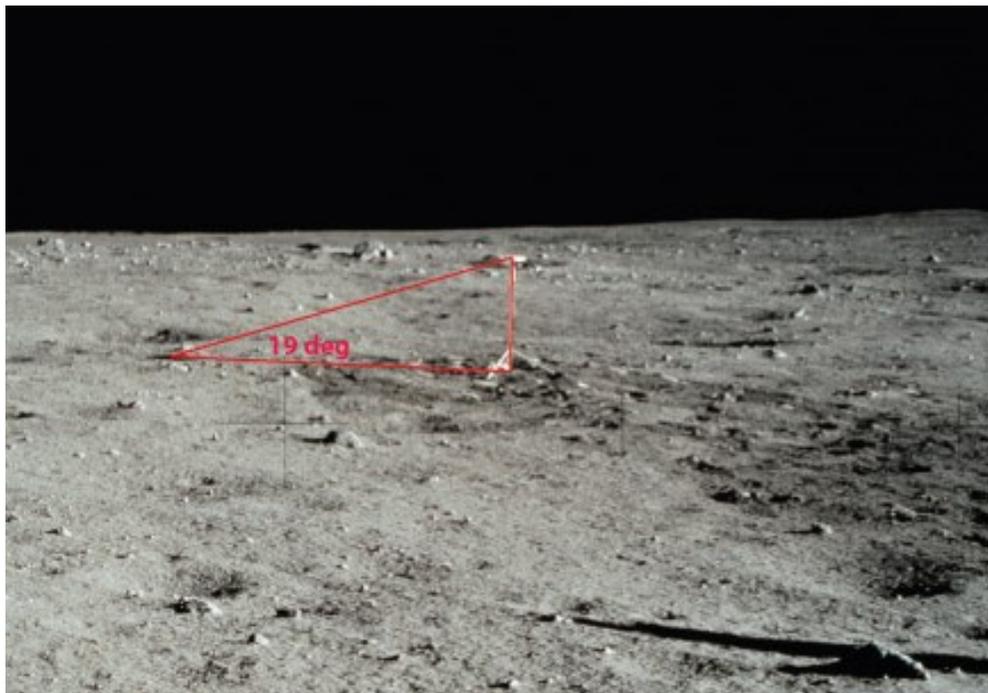
Figure 6 - Analysis of photo AS11-40-5884

This photo shows an instrument located on a tripod. Its top has a flat cylindrical object. The Sun is on the right, and the shadow casts from right to left. Here, we find a Sun elevation angle of 19 degrees, notably higher than it should be at 14.6 degrees.

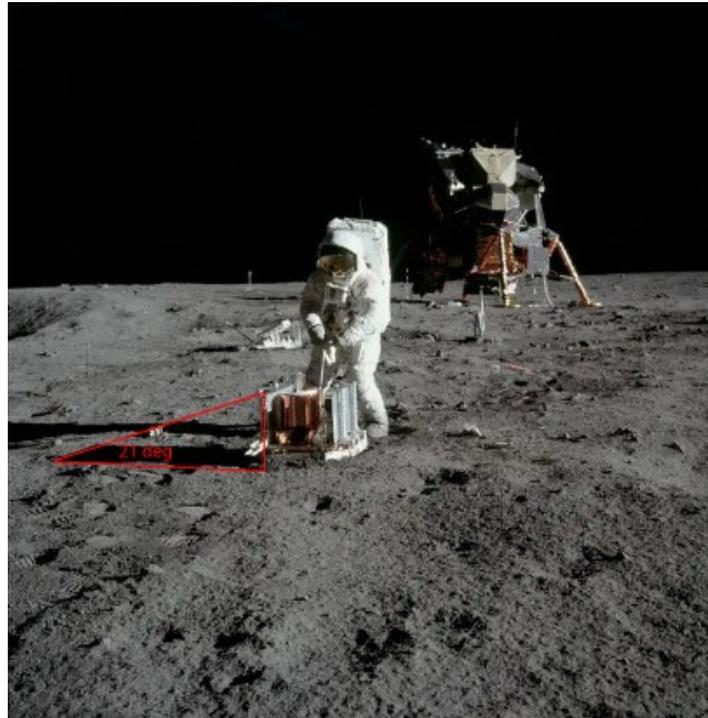
Figure 7- Analysis of Photo AS11-40-5946

This photo shows the Sun elevation angle is 21 degrees, but it should be 14.9 degrees.

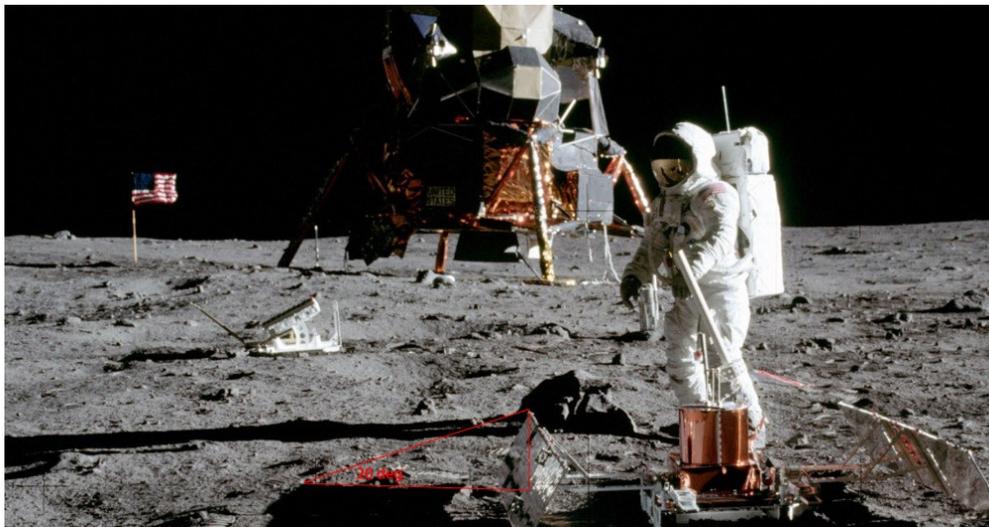
Figure 8- Analysis of Photo AS11-40-5949

The Sun elevation angle calculated in the photo is 20 degrees and should be 15 degrees.

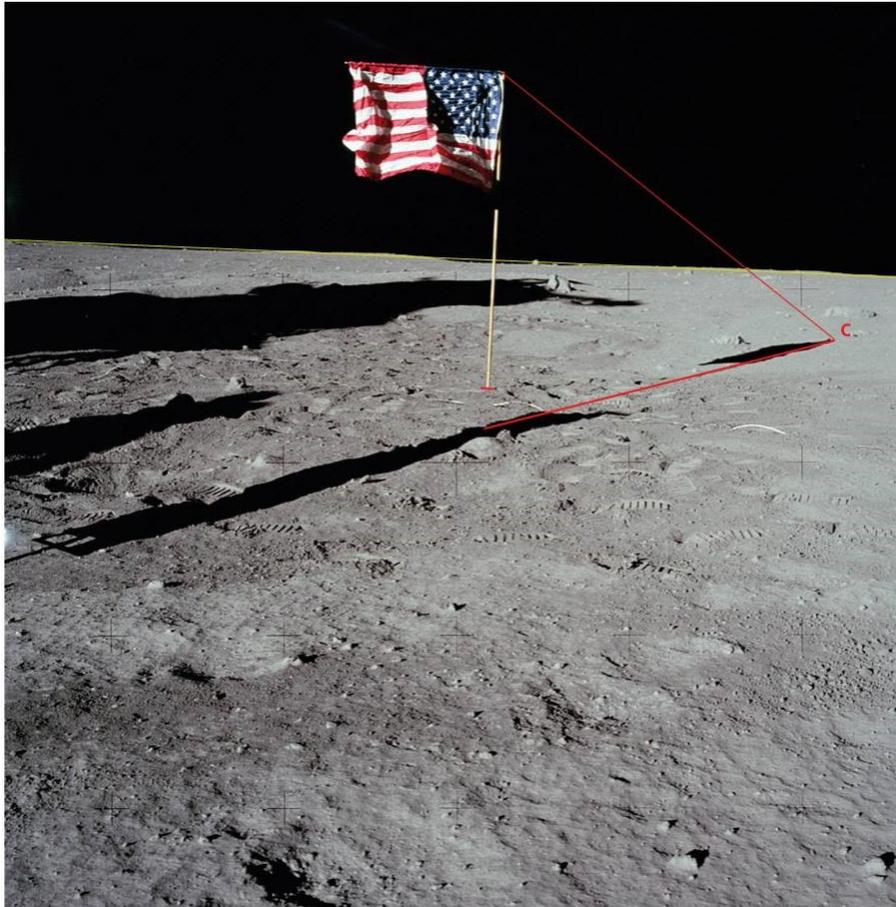
Figure 10- Photo AS11-40-5905. The flag on a small mound.

The image is tilted here, but the flag is perpendicular to the horizon and raised vertically. Notably, the shadow of the flag is well-defined, but the shadow of the pole that holds it is choppy. Projecting the shadow of the vertical pole, we notice that the flag seems to be on a small mound of sand about 20 centimetres tall. See Figure 10 below.

The mound gives the impression the astronauts moved moon dust and gravel over the base to support it when installing the flag. So, it appears elevated from the surrounding terrain, explaining why, in other photos, the shadow of the flag pole is not visible because it lies behind the created mound. The Sun's elevation should be measured up to the buried flag base.

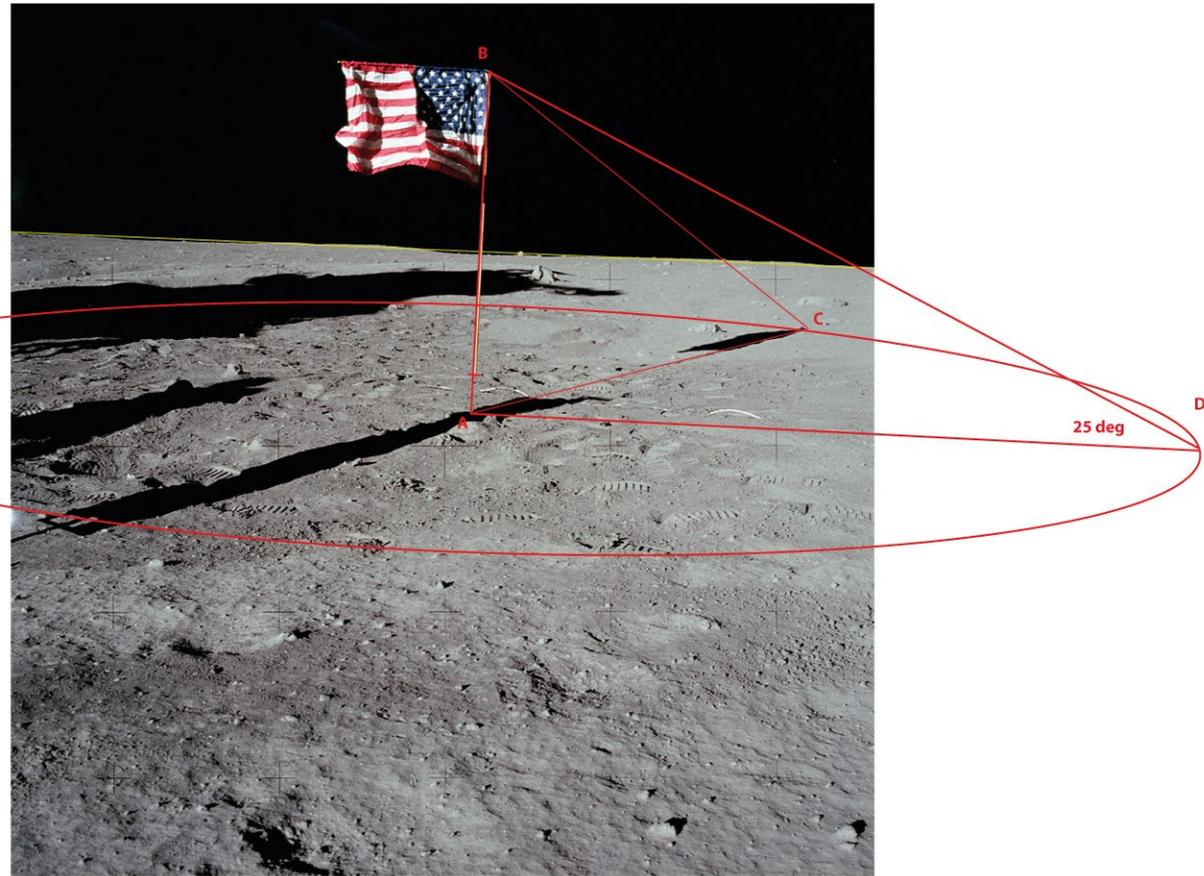
Figure 11- Analysis of Photo AS11-40-5905. The triangle rotated.

Figure 11 shows triangle A-B-C rotated to obtain the triangle A-B-D, which is now in front view. To do this, we draw an ellipse, which is a circle seen from above, that rotates the triangle on it to be analysed. Figure 11 shows this ellipse drawn and illustrated in perspective. One way we can draw the ellipse is with Adobe Illustrator tool. With this tool, we can define the major and minor axis of the ellipse. The proportion between these two axes is in proportion to the Sine function of the dip angle of the base of the flag. The flag base is about 10 degrees below the horizon. How do we know it is 10 degrees? The “+” sign marks on the crosshairs of these photos are 10.3 degrees apart, as shown in Annex B. Drawing this ellipse correctly and in perspective allows us to estimate where the rotated triangle (A-B-D) would be. In the resulting rotated triangle, we can measure the angle at vertex D using the tangent as in Method 1. The tangent of the Sun’s elevation angle will be the segment A-B divided by A-D.

We arrive at an elevation of 25 degrees. But when the photo was taken, NASA’s data with its Horizons tool indicated that the Sun should be at 14.8 degrees elevation. Why is the Sun 10.2 degrees higher? For the Sun to rise this much on the Moon, the astronauts would have had to wait 18 hours. The only conclusion possible is that this photo was not taken during the Apollo 11 mission when NASA says it was.

In this method, the triangle defining the Sun's front view elevation is not visible. So, we cannot directly use it to calculate the Sun's elevations as we did in Method 1. The shadow is not cast from right to left or left to right but backwards. So, we must rotate the triangle to the front view to measure it correctly.

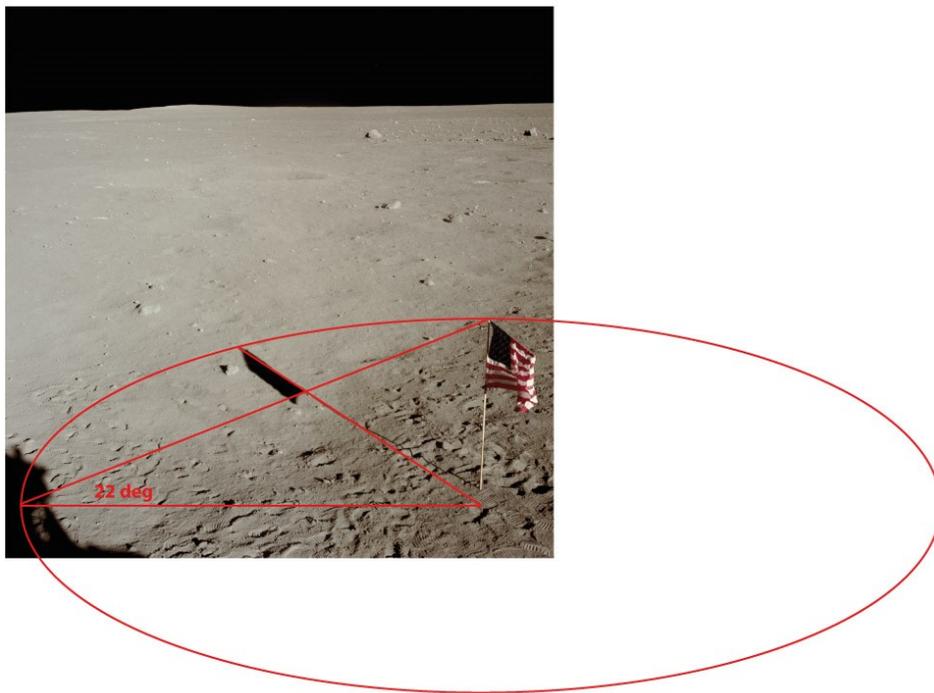
Figure 13- Analysis of Photo AS11-37-5466.

We have the US flag again (Figures 12 & 13) but now taken from inside the capsule, after the Extra-Vehicular Activities at 112h 20m 56sec after the Apollo 11 lift-off. The flag, again, is on a little mound. The Sun's elevation angle should be 15.6 degrees, but it is actually 22 degrees.

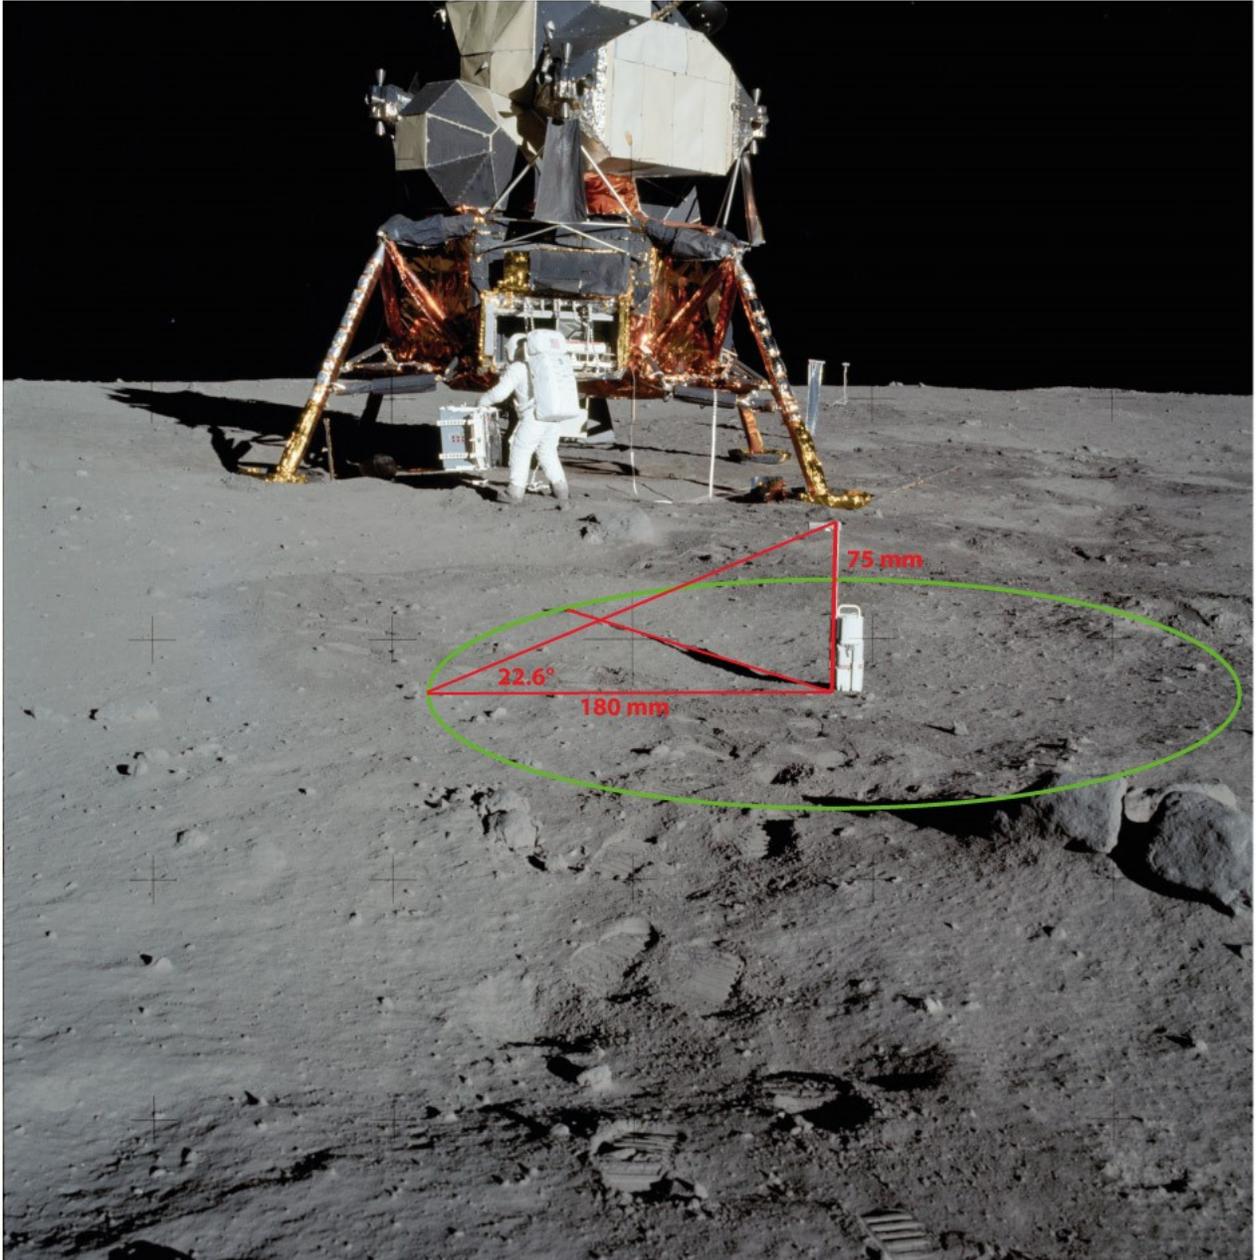
Figure 14- Analysis of the photo AS11-40-5931.

We see one of the instruments the astronauts installed. Its base is 13 degrees below the horizon and that helps to draw the ellipse in a ratio between the minor axis and the major axis equal to the Sine of 13 degrees, as explained above. The dimensions were measured on the computer screen and the resulting angle is 22.6 degrees. It should be 14.9 degrees.

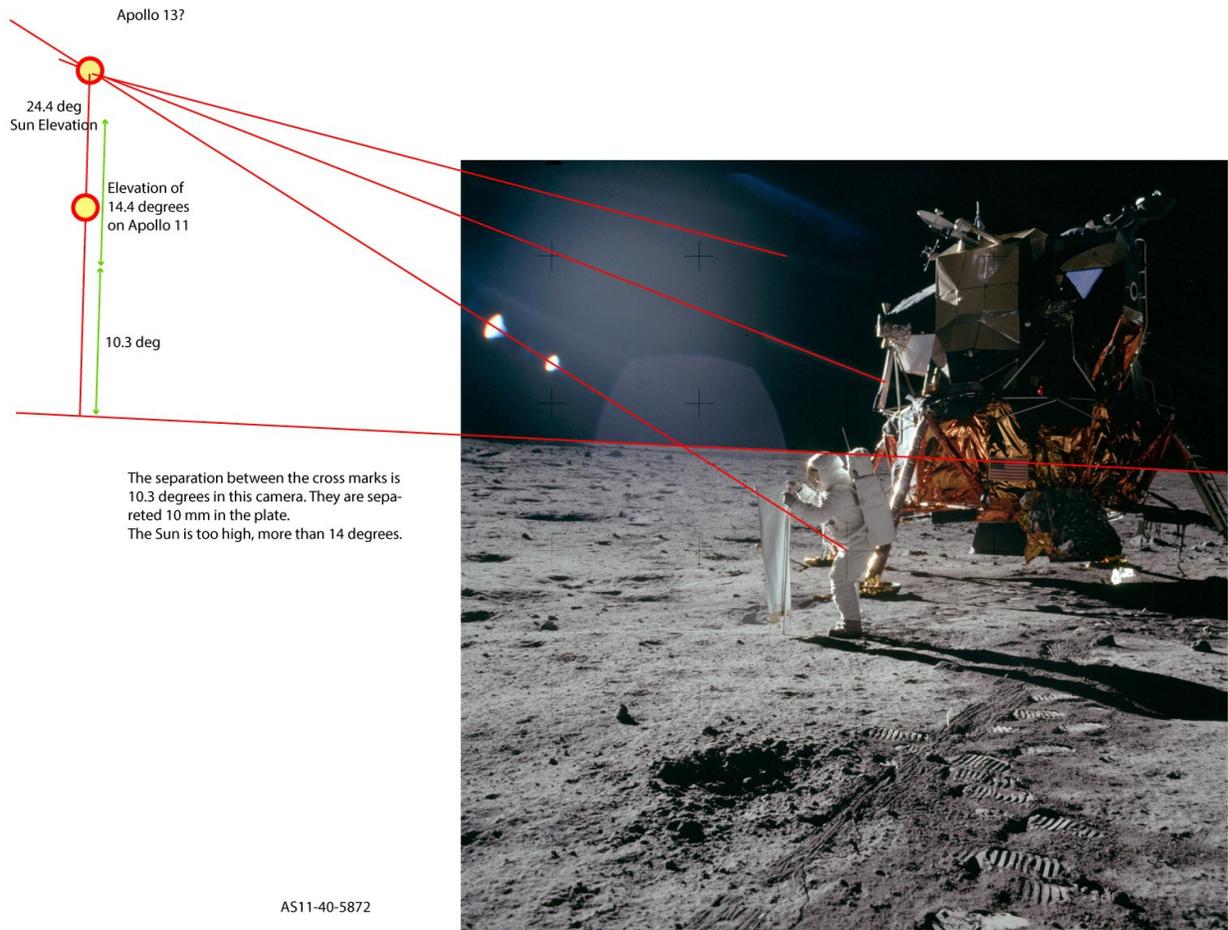
Figure 16- Analysis of Photo AS11-40-5872.

The green arrows in the figure represent the 10.3-degree separation between each crosshair mark. Lines indicating the Sun's position are projected, the horizon line drawn, and the Sun's elevation calculated.

The resulting elevation is 24.4 degrees, not the 14.4 it should be if this photo were taken by Apollo 11.

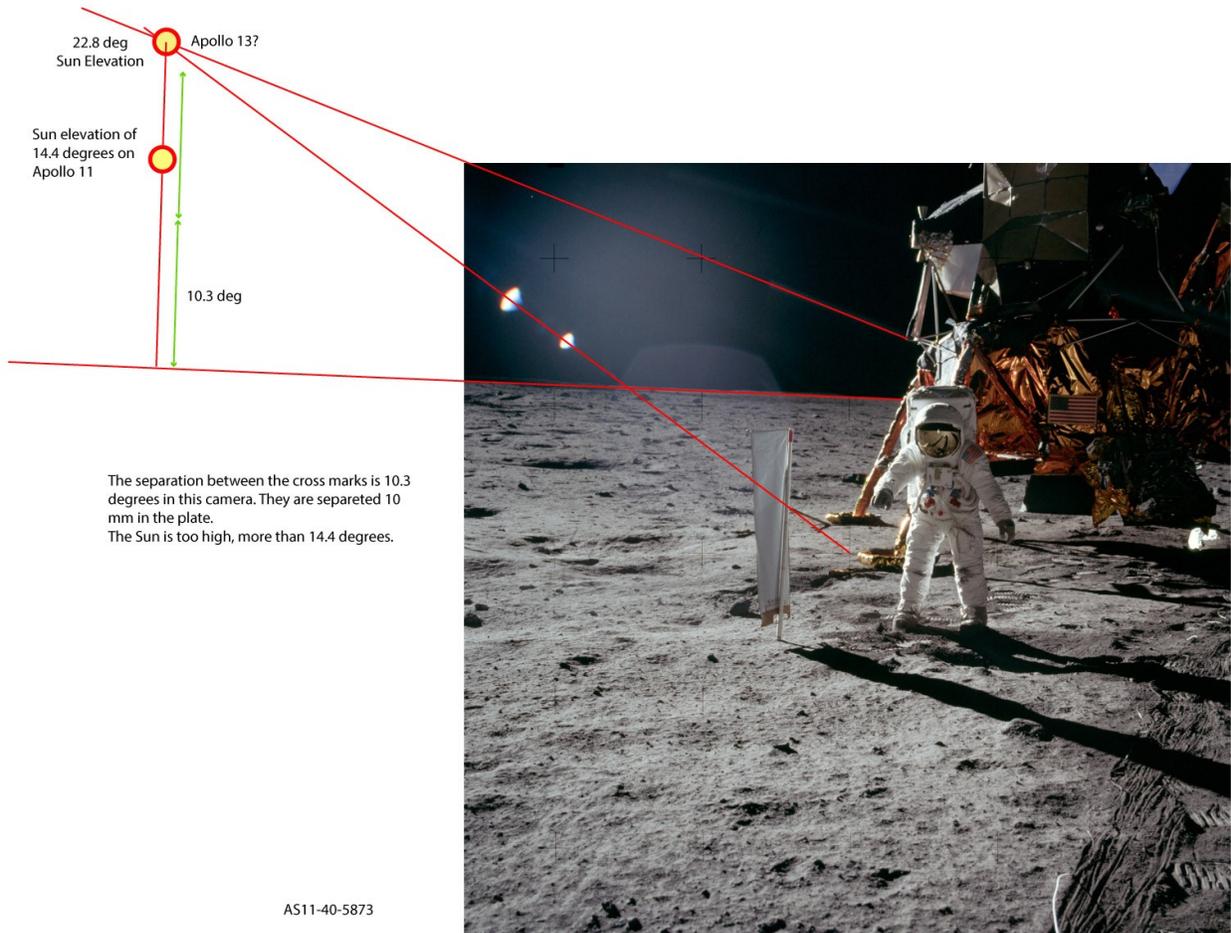
Figure 17- Analysis of Photo AS11-40-5873.

This analysis is similar to the previous one. In this case, we obtain a Sun elevation of 22.8 degrees, not the 14.4 it should be for Apollo 11. So, Apollo 11 astronauts could not have taken this photo.

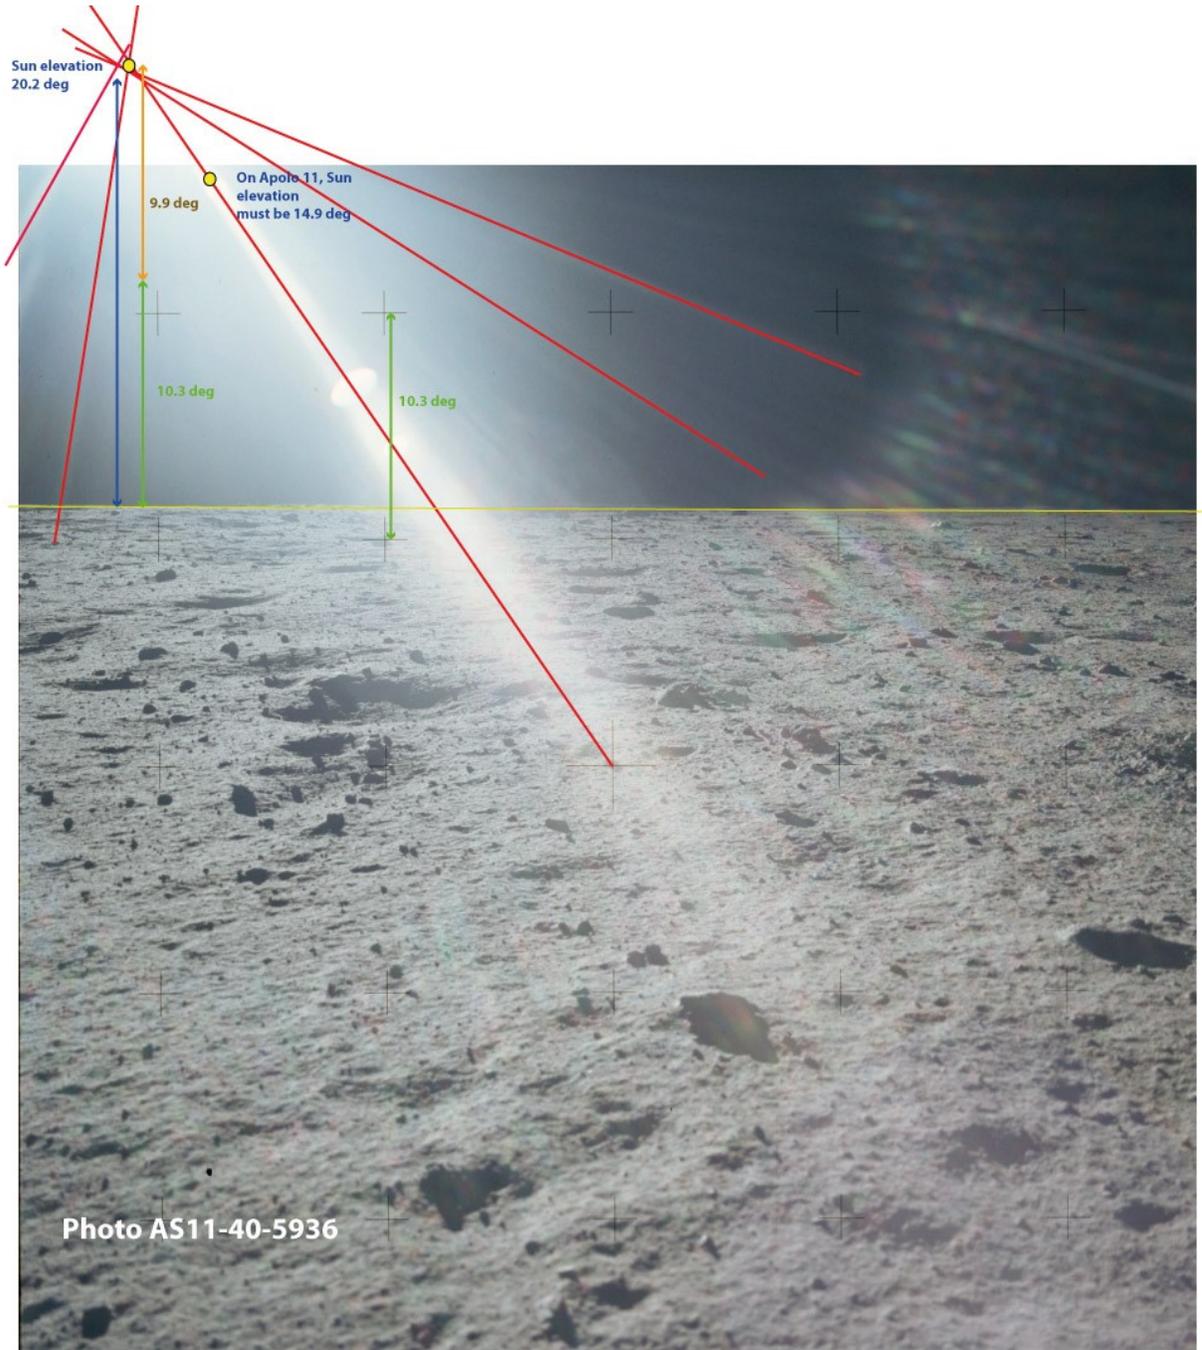
Figure 18- Analysis of Photo AS11-40-5936.

This photo is perhaps the best of the three (see Figure 18). The Sun is closer to the edge of the photo's field of view, and many lines appear, enabling estimation of the Sun's position. Projecting the lines may produce a slight error if the Sun is far from the field of view. The closer the Sun is to the photo area of view, the smaller the error, so this photo may give the most accurate value of the Sun's position.

The Sun's actual elevation in this photo is 20.2 degrees, but if the Apollo 11 astronauts had taken it, it should be 14.9 degrees; the Sun should appear in the photo's field of view. So, this photo could not have been taken during the Apollo 11 mission. This photo, with the Sun in the field of view, must be overexposed and it is not.

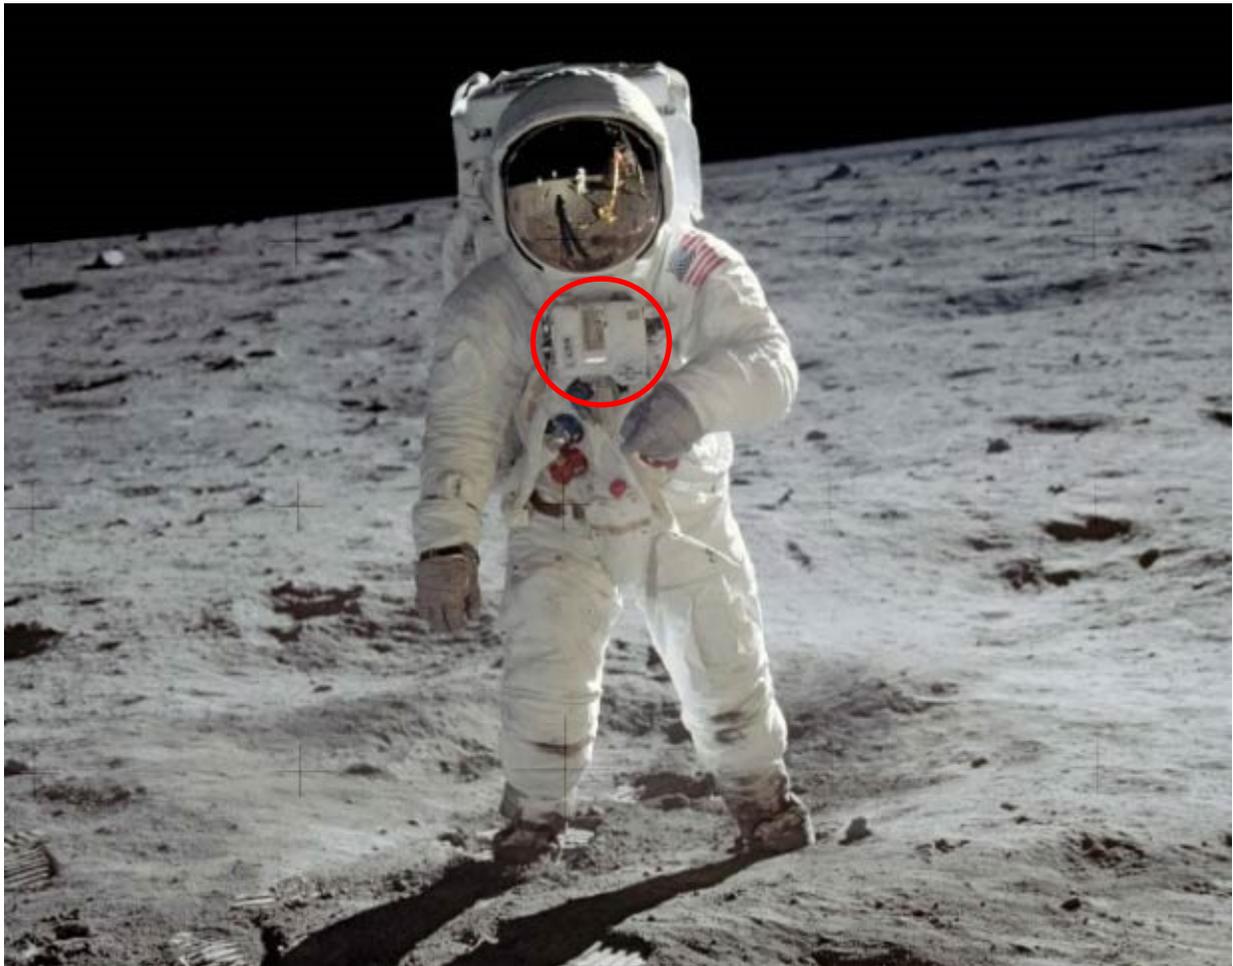
Figure 19- Location of the camera on the astronaut's chest.

In this method we will also use the reticule with marks 10.3 degrees apart, but instead of observing the position of the Sun, we will observe the opposite point of the Sun. That is, the point that is 180 degrees to the opposite side, and instead of being above the horizon at an angle of elevation, it will be that same value at an angle of dip. If the Sun should be at 15 degrees elevation, the opposite point should be at 15 degrees dip. To do this, we must understand that the camera was carried by the astronauts on their chest, fixed. In this way they had their hands free. See figure 19 where the location of the camera on the spacesuit is indicated.

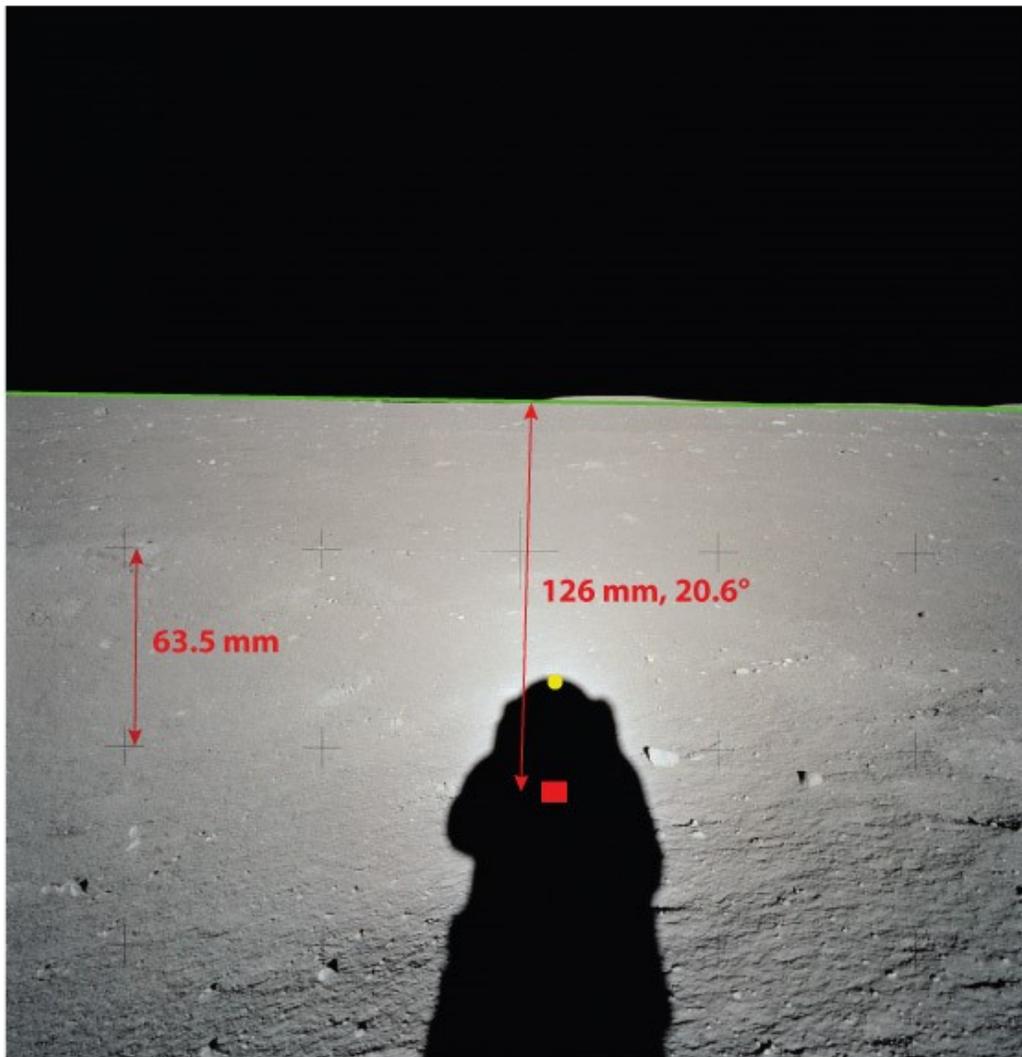
Figura 20- Análisis de la foto AS11-40-5882.

We see the silhouette of the astronaut's shadow. The camera must be on the chest, on the red square mark. Therefore, the point opposite the Sun should be at that location. If we draw a straight line from the Sun, passing through the camera lens, it will be projected to the opposite point of the Sun. This helps us to measure the dip angle, which is equal to the elevation angle of the Sun at that instant.

On the computer screen we measure that the crosshair marks, which indicate 10.3 degrees of angular separation, are at 63.5 mm. By measuring the distance from the camera to the horizon, in this case 126 mm, we can calculate the angle proportionally, which gives us 20.6 degrees of dip. The Sun was in this photo at 20.6 degrees elevation, not 15 degrees. For it to be 15 degrees, the camera would have to be in the yellow circle. But we know that the astronaut did not have the camera over his head.

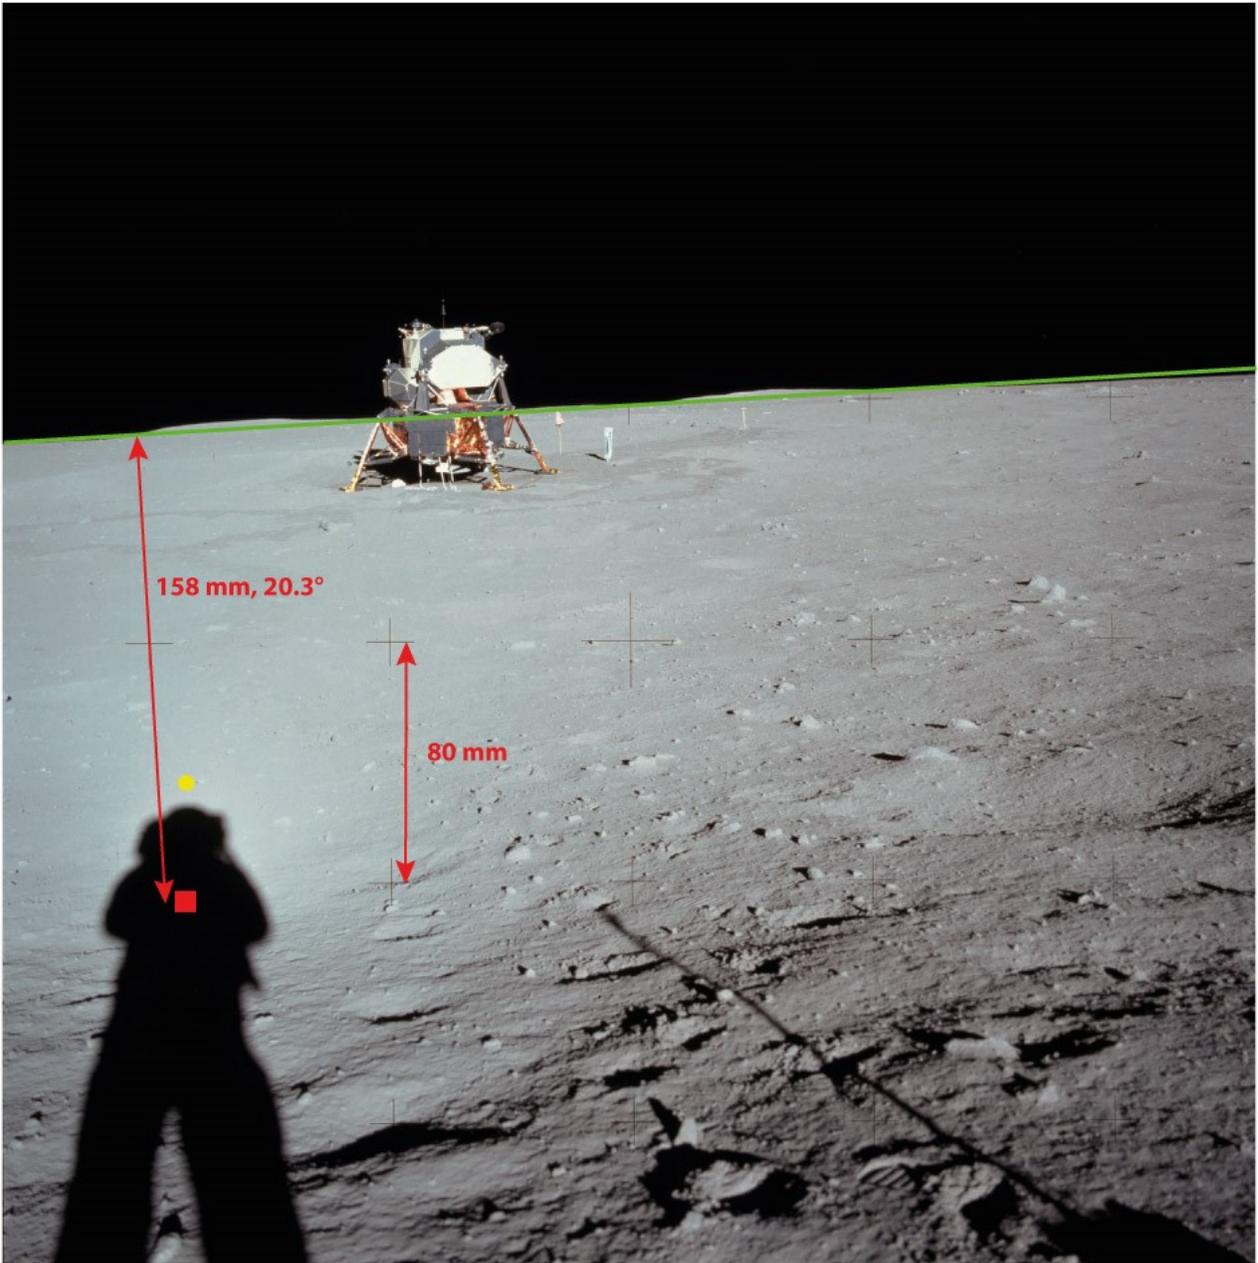
Figura 21- Análisis de la foto AS11-40-5962.

Here we get an elevation angle of the Sun of 21.6 degrees. It should be 15 degrees. And if it were 15 degrees, here too the camera should be above the astronaut.

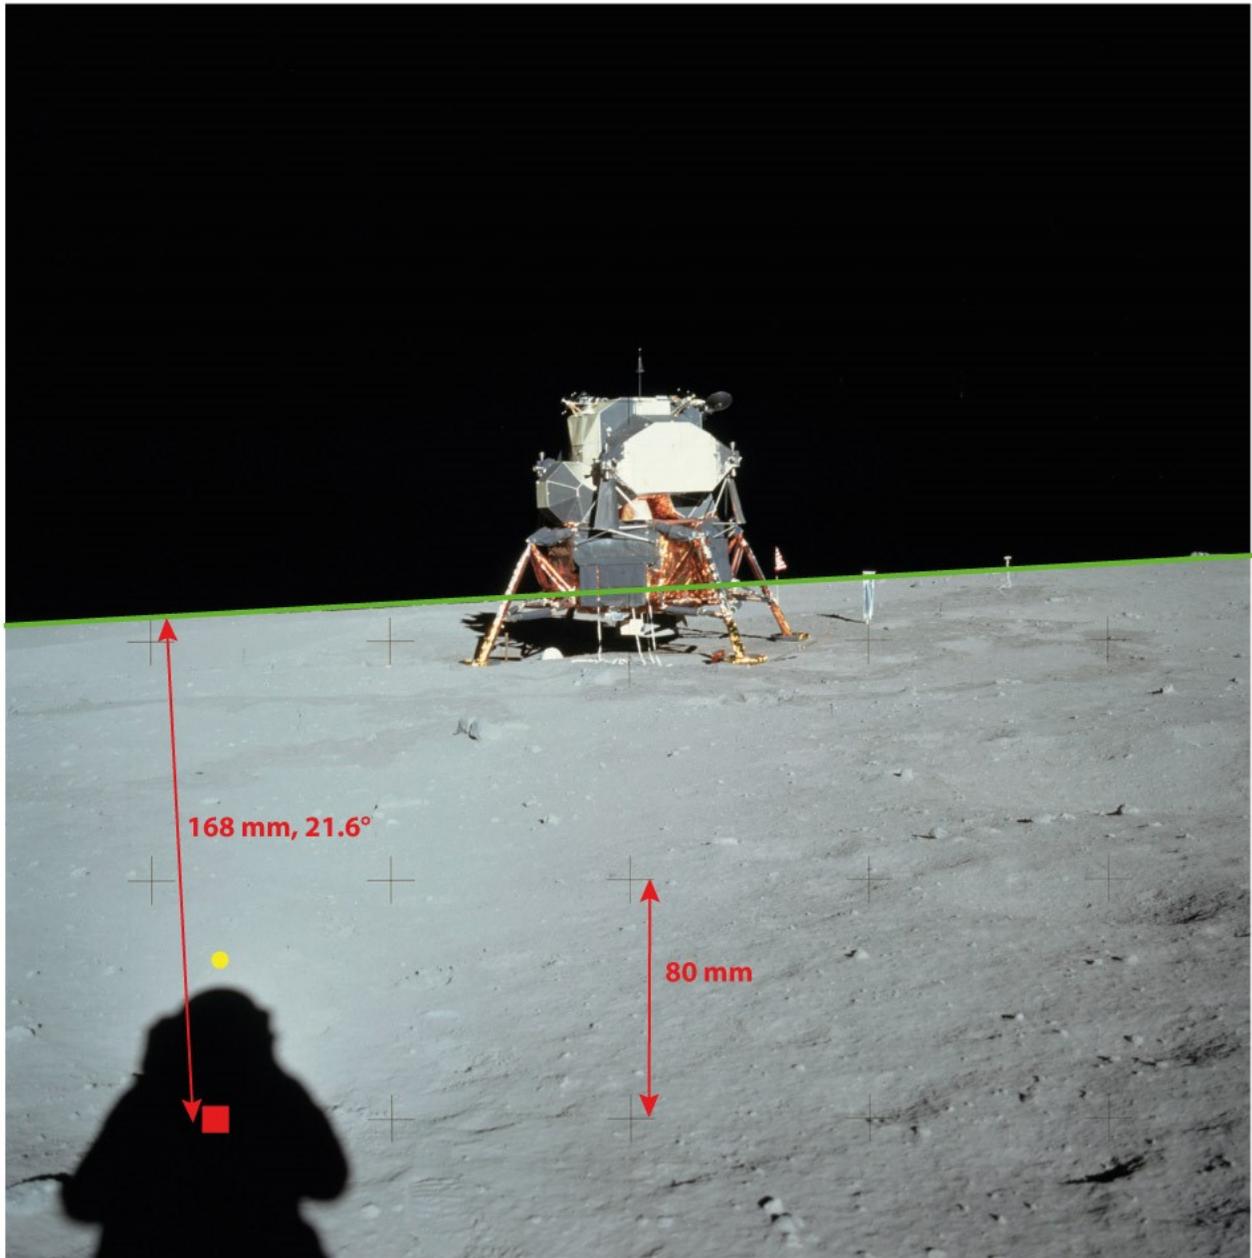
Figura 21- Análisis de la foto AS11-40-5961.

A similar photo, showing the silhouette of the astronaut. Here we get an elevation angle of the Sun of 20.3 degrees. It should be 15 degrees. And if it were 15 degrees, the camera should be above the astronaut, which is totally illogical.

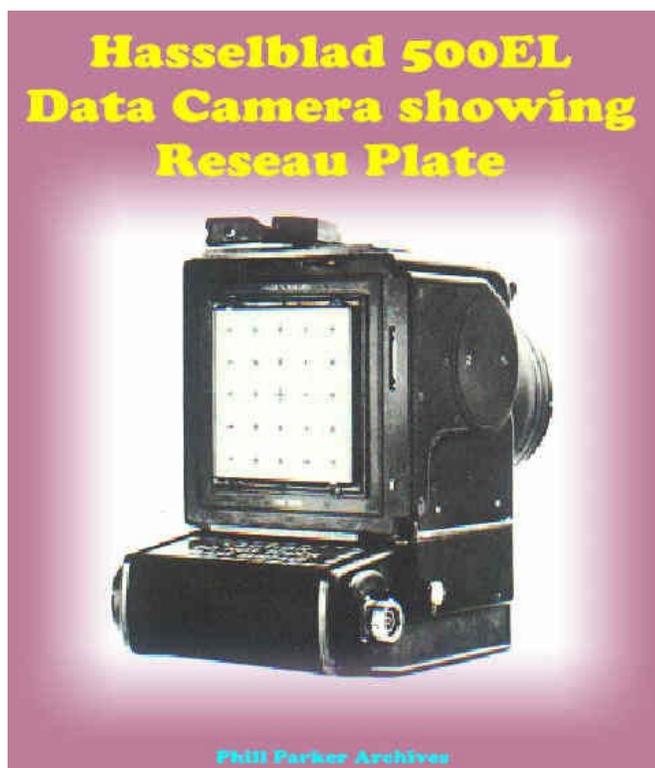
Reseau Plate

The Hasselblad Lunar Surface Data Camera was fitted with a Reseau plate, which provides a means of correcting images for the effects of film distortion. The Reseau plate was made of glass and was fitted to the back of the camera body, extremely close to the film plane. The plate was 5.4 x 5.4 cm in the film plane, which was the useful exposure area on the 70 mm film.

The Reseau plate was engraved with a 5 x 5 grid of crosses. The intersections of the crosses were 10 mm apart and accurately calibrated to a tolerance of 0.002 mm.
